AVIATION INVESTIGATION REPORT

A03O0135

LOSS OF CONTROL ON WATER

DE HAVILLAND DHC-6-300 (AMPHIBIOUS) C-GOGC

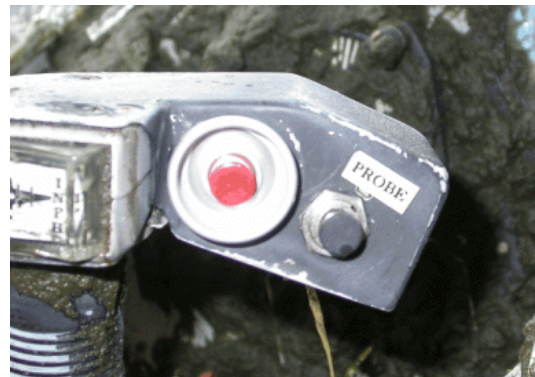
Photo 1. Bomb door and probe switches on aircraft yoke

C-GOGC was not equipped with a hinged cover plate over the bomb door switch. It was reported that the original switch became unserviceable and was replaced, but the hinged cover plate was not reinstalled. During the investigation, a second MNR Twin Otter was flown to Hornepayne, and it was observed to have a hinged cover plate covering the bomb door switch.

During the approach, the Vital Action checklist was not completed as per the SOPs, and the bomb door armed switch was left in the ON position. After completing the scooping operation, the pilot intended to retract the probes by pressing the probe switch but inadvertently pressed the adjacent bomb door switch. Since this system remained armed from the previous bombing run, the doors extended into the water. The drag from the doors and the water rushing into the floats through the door openings resulted in the aircraft nosing over. The proximity of the probe and bomb door push button switches and the missing cover plate on the bomb door switch increased the likelihood of selecting the bomb door switch instead of the probe switch.

The MNR has verified that every Twin Otter aircraft in their fleet is equipped with the cover plate over the bomb door push button switch. The MNR will ensure that any future modifications to aircraft will be standardized to decrease the potential for inadvertent operation of systems.

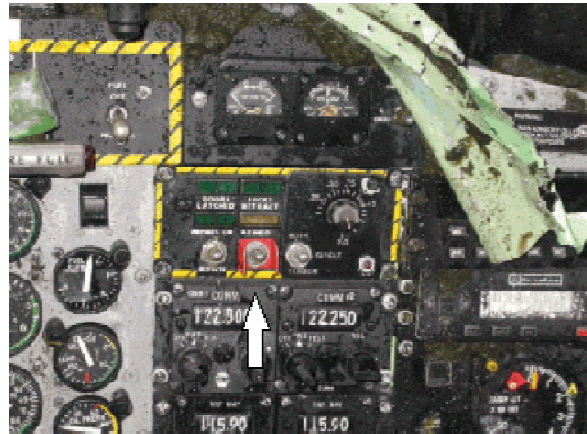
Prior to scooping, the bomb door armed switch on the centre panel must be selected OFF to prevent the inadvertent activation of the bomb door open operation if the bomb door push button switch is pressed. The armed switch should be ON only after the scooping operation is complete and the floats have cleared the water surface. After the occurrence, when the position of the centre panel switches were examined, the door armed switch was found in the ON position.

Photo 2. System indicating lights and door armed switch (indicated by white arrow) in the On position

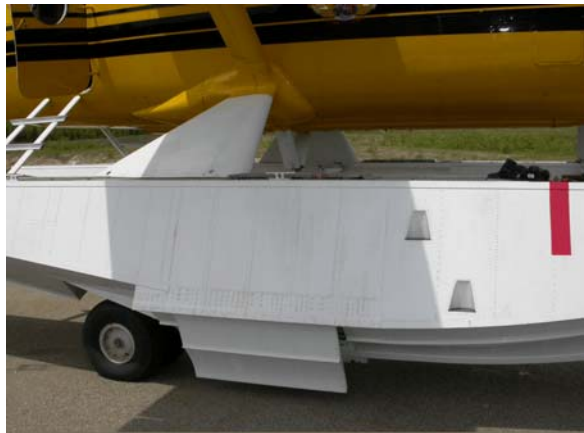
On initial examination of the aircraft, the right bomb doors were found in the extended position. The left bomb doors were closed, but there were indications of damage where the trailing edge of the doors and the float interface. When the aircraft was raised to an upright position, both sets of left bomb doors free fell to the extended position. The probes were fully extended.

Photo 3. Left bomb door open

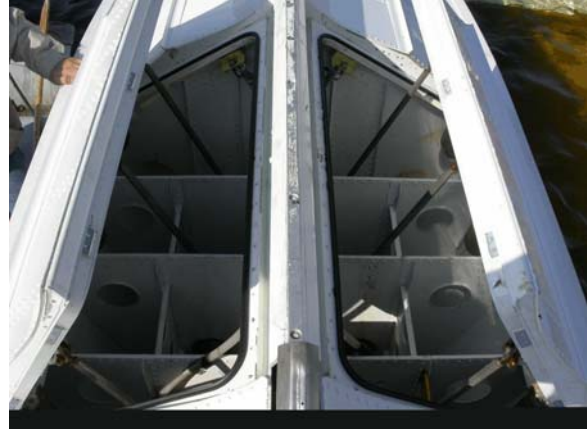
Photo 4. Bomb doors open (float upside down)
